## Survey and excavations at Solomon's Pools, Palestine: 2018 preliminary report

This article provides an initial archaeological and historical overview of the Lower Pool at the Pools of Solomon south of Bethlehem, Palestine.

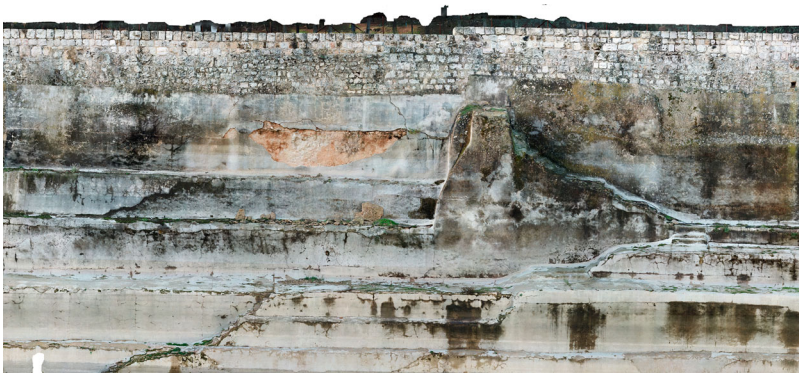
secured by mortar in at least two distinct phases (Figure 8). The interface of the bedrock and the built wall on top of it can be seen at the point where the buckling wall has caused plaster to fall from the seam (Figure 9). At this same level, immediately to the west of the buckling, a bedrock-hewn staircase within the pool reaches its height, apparently put out of commission by the construction of the built wall. The built wall that exists now, therefore, was not a part of the original construction of the pool.

**Figure 9.** Orthophoto of the Southern Wall of the Lower Pool, showing collapsed plaster due to the buckling of the wall above. Collapsed plaster reveals bedrock with upper retaining wall. Note bedrock staircase cut off at centre right. The upper two courses of wall are of relatively recent vintage (ca. Medieval-modern).

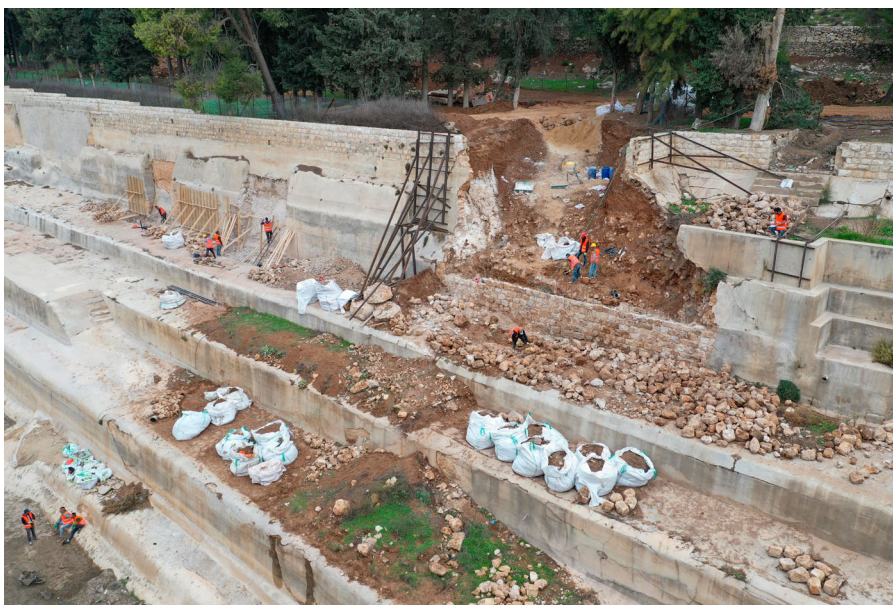
**Figure 14.** Photo of break in the North Wall of the Lower Pool after cleaning showing ongoing reconstruction work at the site.

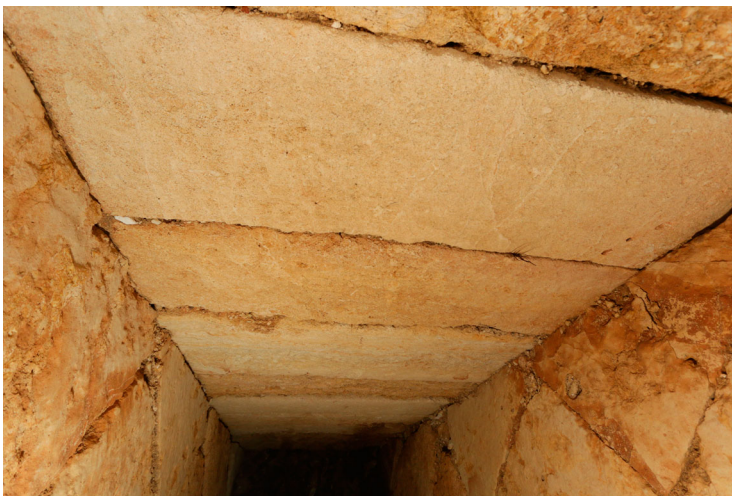
**Figure 24.** Photo of the ceiling blocks within the Dam staircase.
