Survey and excavations at Solomon's Pools, Palestine: 2018 preliminary report

This article provides an initial archaeological and historical overview of the Lower Pool at the Pools of Solomon south of Bethlehem, Palestine.

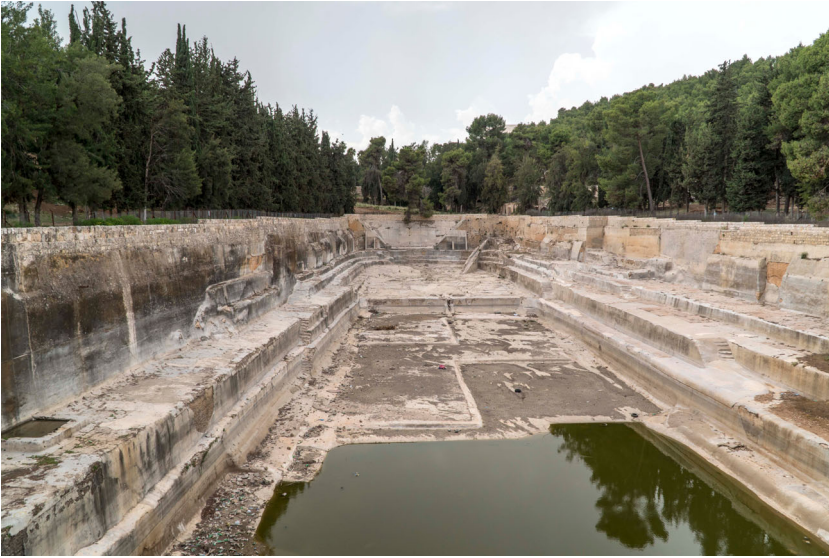
Figure 5. General photo of the Lower Pool from on top of the Dam Wall, looking west.

filled with another material with a reddish matrix (Figure 5). This plastering was carried out during the British Mandate Period. In photographs before 1930, a plaster of a different character (without joints) is evident. The latest layer of plaster obscures many of the architectural elements of the pools, however earlier plasters continued to function in many areas and can be documented. Furthermore, degradation of the most recent plaster has resulted in numerous breakages which provide windows into some of the underlying architectural components of the pool.

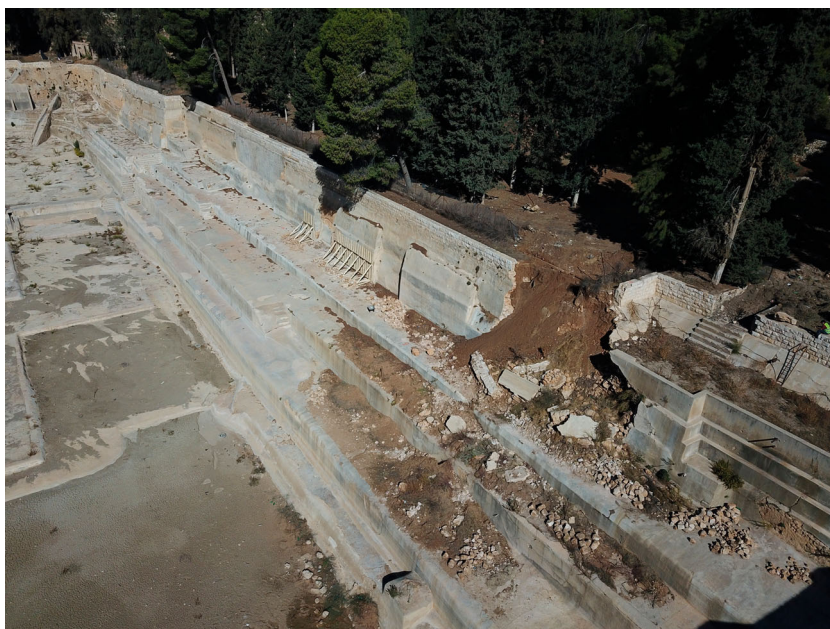
Additional data concerning the architectural history of the LP was accessible due to the recent collapse of a ca. nine-metre section of the northern wall (Figure 6). The collapse, and the construction and conservation work carried out to repair it, allowed for visual inspection of wall at that location that yielded a number of stratigraphic observations. Buckling of the upper portions of the south wall also provided an opportunity to record aspects of the constructional history of the pool at that location through a test trench abutting the exterior of the wall.⁴ These opportunities to investigate the pool (along with other investigations of that dam wall, detailed separately below) have allowed for the establishment of a baseline stratigraphic framework that can be applied to the whole pool.

Figure 6. Photo of the collapsed portion of the North Wall of the Lower Pool.

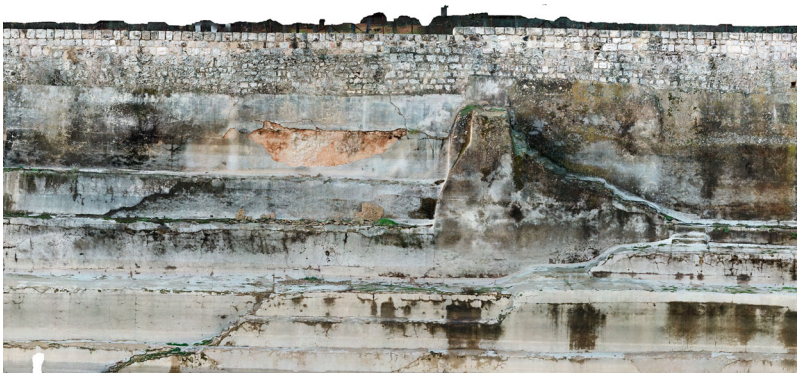
secured by mortar in at least two distinct phases (Figure 8). The interface of the bedrock and the built wall on top of it can be seen at the point where the buckling wall has caused plaster to fall from the seam (Figure 9). At this same level, immediately to the west of the buckling, a bedrock-hewn staircase within the pool reaches its height, apparently put out of commission by the construction of the built wall. The built wall that exists now, therefore, was not a part of the original construction of the pool.

Figure 9. Orthophoto of the Southern Wall of the Lower Pool, showing collapsed plaster due to the buckling of the wall above. Collapsed plaster reveals bedrock with upper retaining wall. Note bedrock staircase cut off at centre right. The upper two courses of wall are of relatively recent vintage (ca. Medieval-modern).

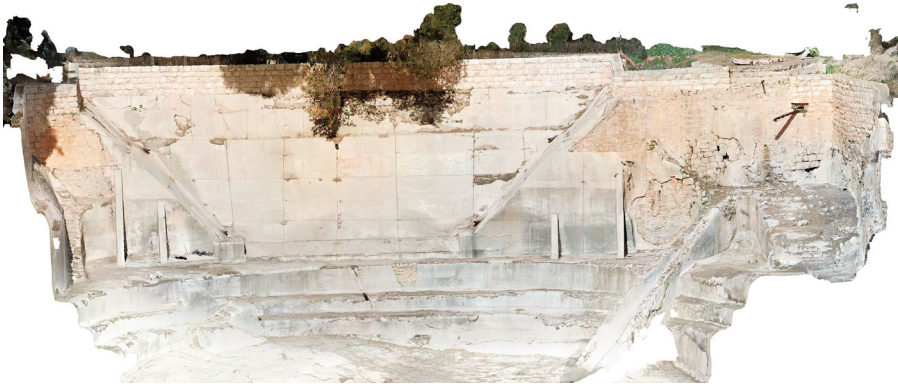
The majority of the western wall is covered by a poured concrete revetment with steel pipe inlets (Figure 10). A similar addition to the pool is in the northwest corner, also of poured concrete. These renovations took place in the years between 1923 and 1939, most likely in 1932 as a result of a breach in the wall caused by flash flooding (*Palestine Bulletin* 1932). These two renovations comprise the latest significant interventions in the LP, though smaller additions were made periodically since then (see below).

Figure 10. Orthophoto of the West Wall of the Lower Pool.

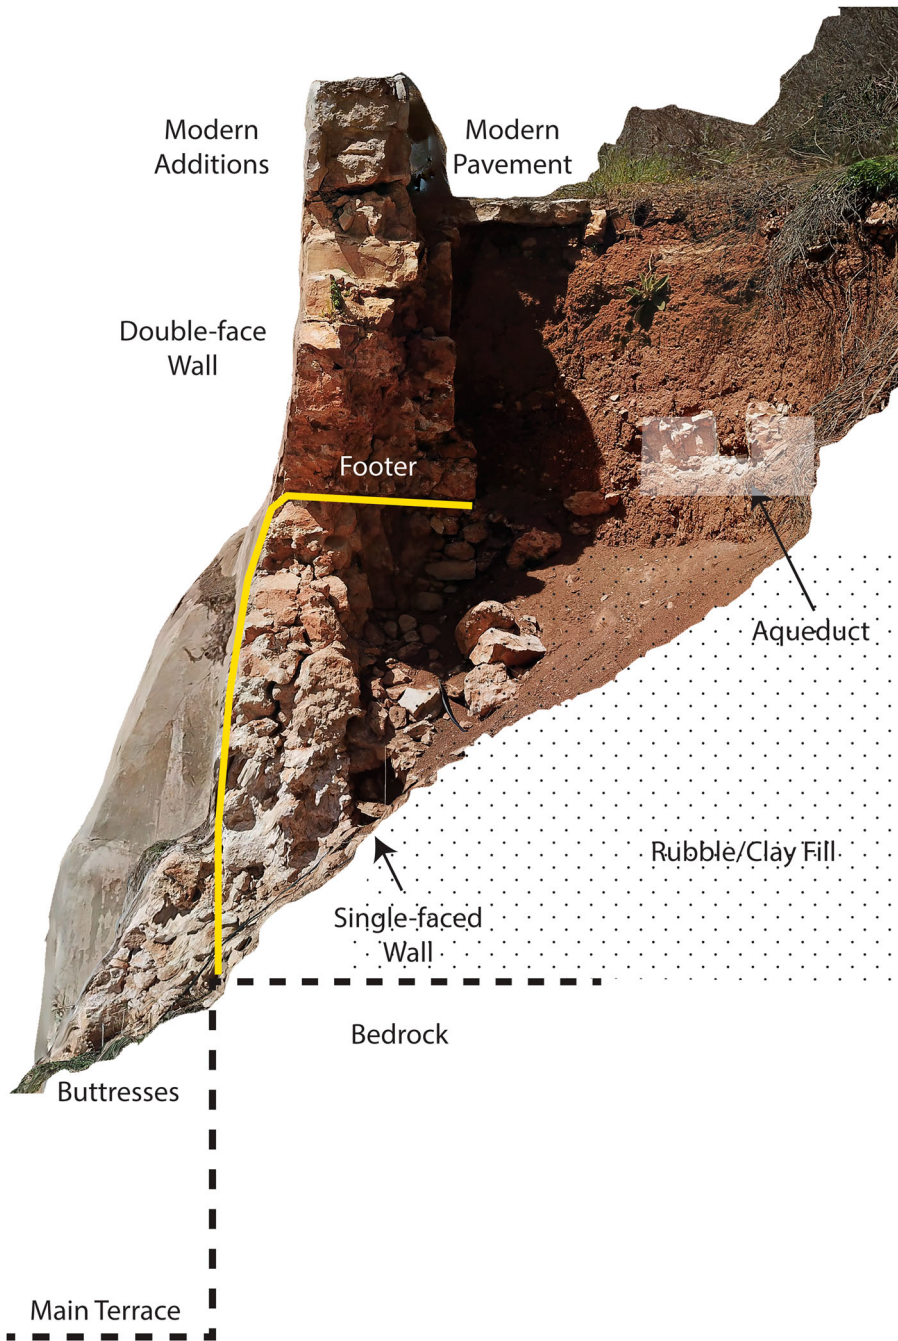
Figure 13. Strata in collapse of northern wall. At bottom, the ‘single face wall’ is the earliest discernable at this location, due to debris still covering the lowest portions. This single-face wall is of a revetment style, built up against a cut section of earth and meant to support it. The ‘double-face wall’ was designed as freestanding, and thus earth built up against the outside of it is stratigraphically later.

Above the single-faced revetment wall is a later wall with cut blocks and both inner and outer face (Figure 13). The wall was constructed with a wider footer that was probably below grade, but the majority of the wall appears to have been freestanding. The lowest course coincides with the upper level of an aqueduct three metres north of the wall and running parallel to it (Figure 13), and we presume them to be contemporary. The double-face wall with footer was also identified in the southern wall during the test trench excavation.⁵

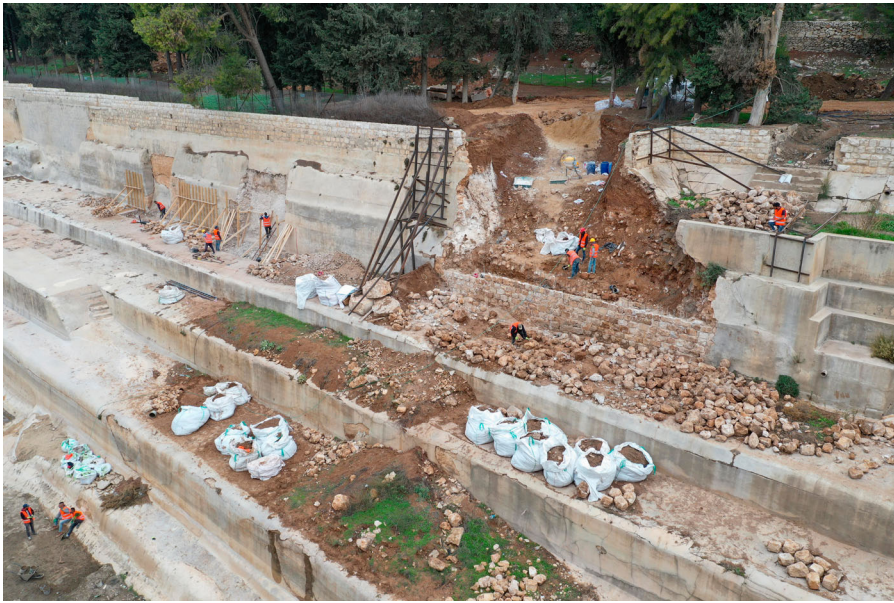
Figure 14. Photo of break in the North Wall of the Lower Pool after cleaning showing ongoing reconstruction work at the site.

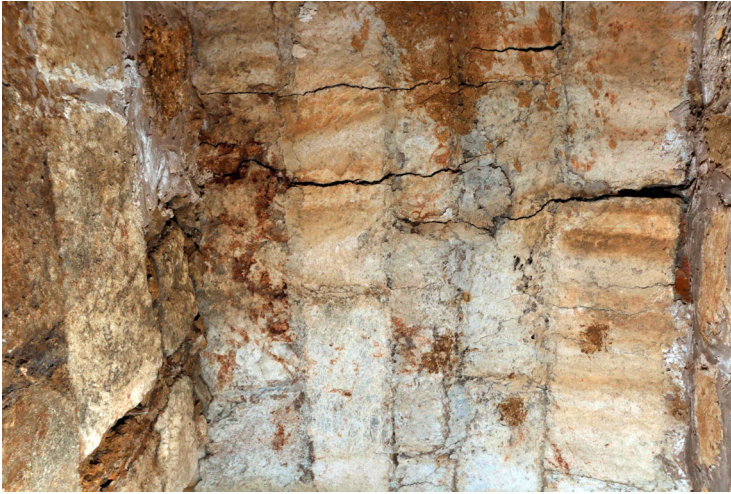
Figure 21. Photo of cracked ceiling within the interior chamber.

Significant damage to the Dam Wall can be seen within the interior structures, including the lateral movement of the staircase, the exterior wall at the entrance to the central chamber, and the cracking within the ceiling of the chamber. It is not clear if this damage happened over time or was the result of a single episode such as an earthquake. It is also unclear if the damage began a period of abandonment of the pool or if the pool was no longer in use when the damage occurred.

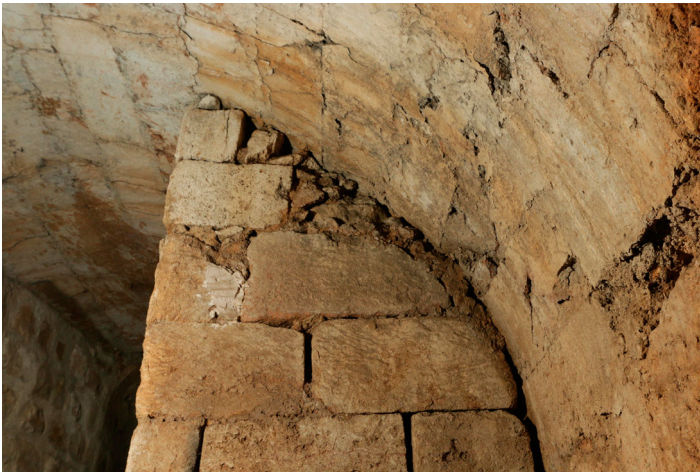
and the buttress has been constructed to prevent further collapse (Figure 24). Within the rectangular vaulted chamber two buttresses were added at the centre of the north and south walls to support the ceiling (Figure 22). Additional support was added to these buttresses in the last two decades.

Figure 22. Photo of the first buttress against the south wall of the original chamber.
