## Survey and excavations at Solomon's Pools, Palestine: 2018 preliminary report

This article provides an initial archaeological and historical overview of the Lower Pool at the Pools of Solomon south of Bethlehem, Palestine.

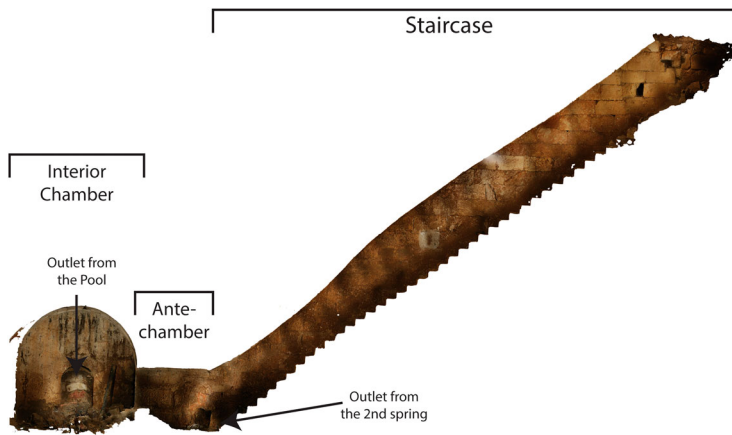
**Figure 23.** Orthophotographic section through the Dam interior chamber and staircase, facing west.

According to Schick's plan, he saw the antechamber and the eastern passageway, but in his day, the western passage to the second spring and the staircase were blocked. At some point in the last 120 years (and most likely in the last 20 years) someone broke through the blockage, evidence of this blockage can still be seen by fragments of sinter still *in situ*.

Significant damage to the Dam Wall can be seen within the interior structures, including the lateral movement of the staircase, the exterior wall at the entrance to the central chamber, and the cracking within the ceiling of the chamber. It is not clear if this damage happened over time or was the result of a single episode such as an earthquake. It is also unclear if the damage began a period of abandonment of the pool or if the pool was no longer in use when the damage occurred.

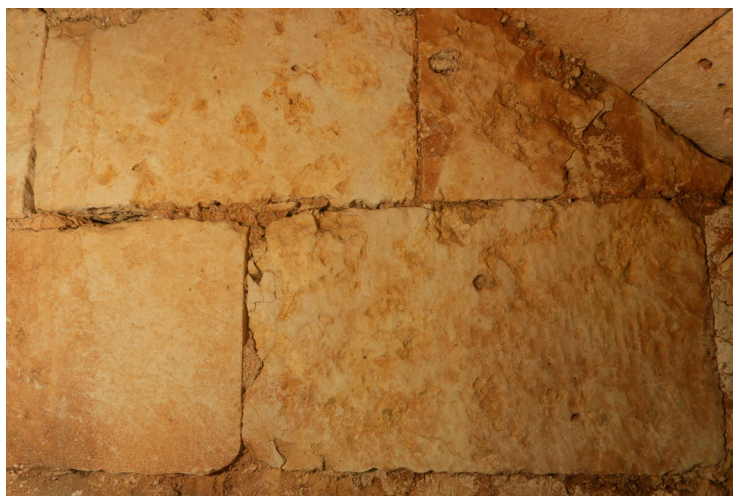
**Figure 25.** Photo of the wall blocks within the Dam staircase.
