Survey and excavations at Solomon's Pools, Palestine: 2018 preliminary report

This article provides an initial archaeological and historical overview of the Lower Pool at the Pools of Solomon south of Bethlehem, Palestine.

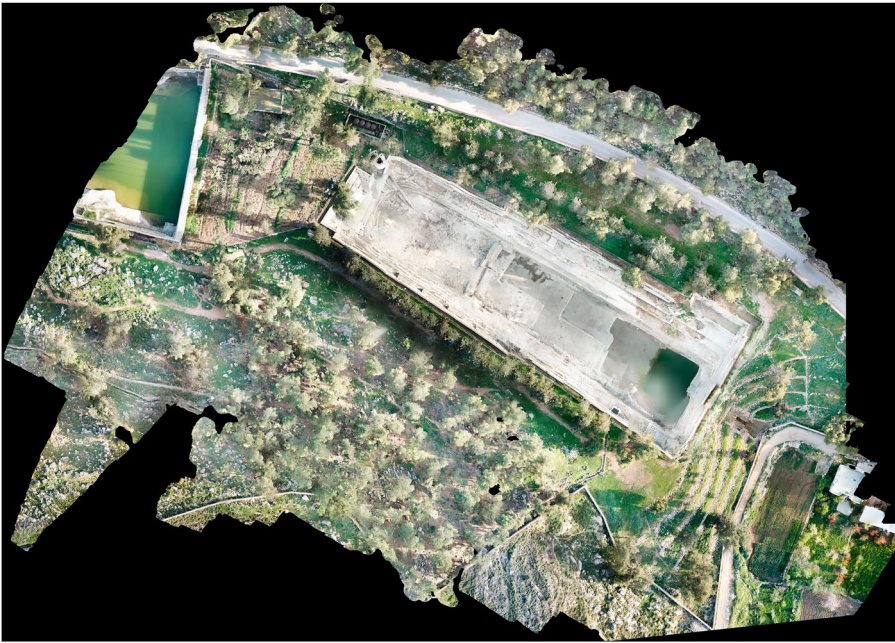
Figure 4. Orthophoto of the Lower Pool. North is up. Data collected 21 March 2018.

4. An on-site visual survey and study of the 3D models documented various components of the pool and identified damaged areas of the pool to be addressed by the conservation team.
5. Small test trenches were excavated at key locations to prepare for engineering works and to verify constructional history of some of the walls of the pool.
6. During conservation works, additional archaeological data was documented.

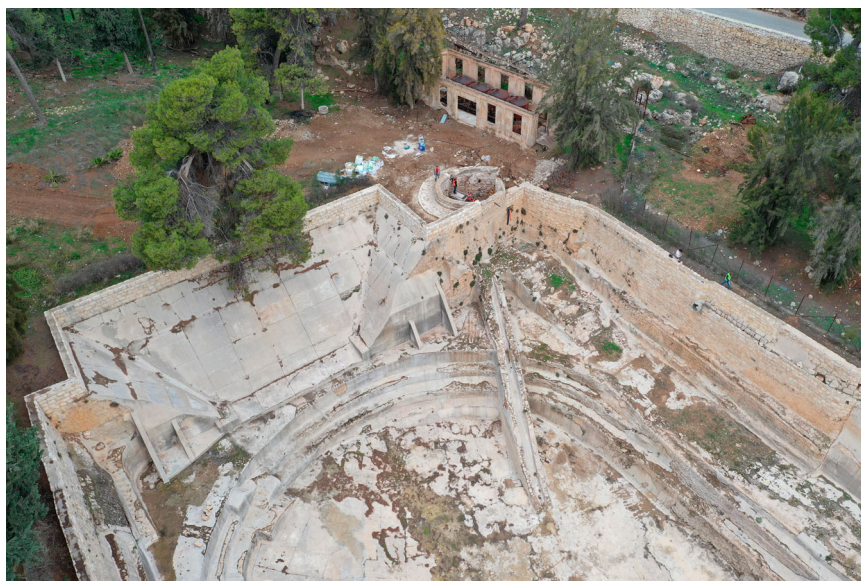
Figure 7. Photo of the northwest corner of the Lower Pool showing examples of the interior terraces of the pool. The large portion of the South Wall that is part of the British Mandate renovation. Note the sloping channel into the pool at centre.

Just outside the northwest corner of the pools is a large stone-lined tank, 3.5 metres deep that acts as a settling basin for water entering to LP from the Middle Pool to the east (Figures 7 and 11). Whether or not the tank is original to the pool is not yet clear. It was certainly in use during the Mandate Period, and a segment of an Ottoman-era ceramic pipe can be seen entering the tank. There are two outlets in the eastern wall of the tank lead directly to the pools northwestern corner, where a very complex architectural history can be observed (Figures 11 and 12). This portion of the pool appears to have been the main inlet for water during the entire history of the pool, but further work is needed to elucidate the architectural stratigraphy here.

The native bedrock was not quarried out as deeply in the northwestern interior as it was in the remainder of the pool. An elevated platform at this point shows remains of two basins cut from the bedrock that seem to correspond to two inlet passages coming from the exterior tank (Figures 7 and 11). Immediately east of these basins is a wide staircase that descends to the 'Main Terrace' level within the pool. It is difficult to tell if the basins are original or if they have been cut out of this staircase, which may or may not have continued upwards to the west.

South of these basins is the broken remains of an aqueduct which sloped southwest from this point to the bottom of the pool (Figures 7 and 11). The aqueduct appears to be an original feature of the pool. While most of the channel is covered with plaster, an architectural section cut into the plaster showed that the bulk of the feature comprises bedrock with two courses of hewn stones placed on top to form the outer walls of the channel. The channel is built of stone with a lime mortar and plastered in at least two distinct phases. Remains of at least four layers of plaster around the base of the feature indicate repeated plastering, as well. The earliest plaster within the channel and at the base is a reddish colour, tinted by the inclusion of ceramic grog.

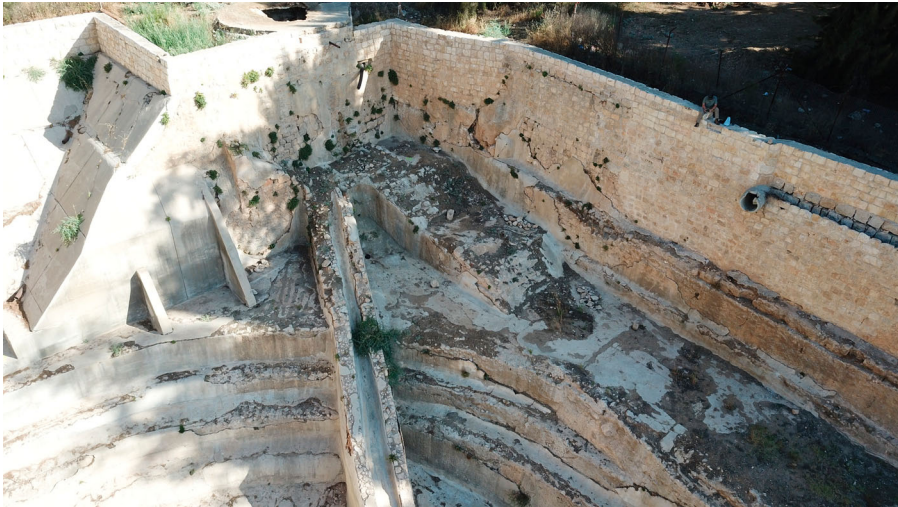
The north wall and especially the northwest corner of the pool is the most architecturally complex, showing numerous rebuilds and additions (Figures 11 and 12). At various places along the north wall, bedrock can be seen behind broken portions of the plaster,

Figure 11. Photo of northwestern corner of the Lower Pool. Note the traces of two basins (filled with earth) at the top of the sloping channel and the wide staircase.

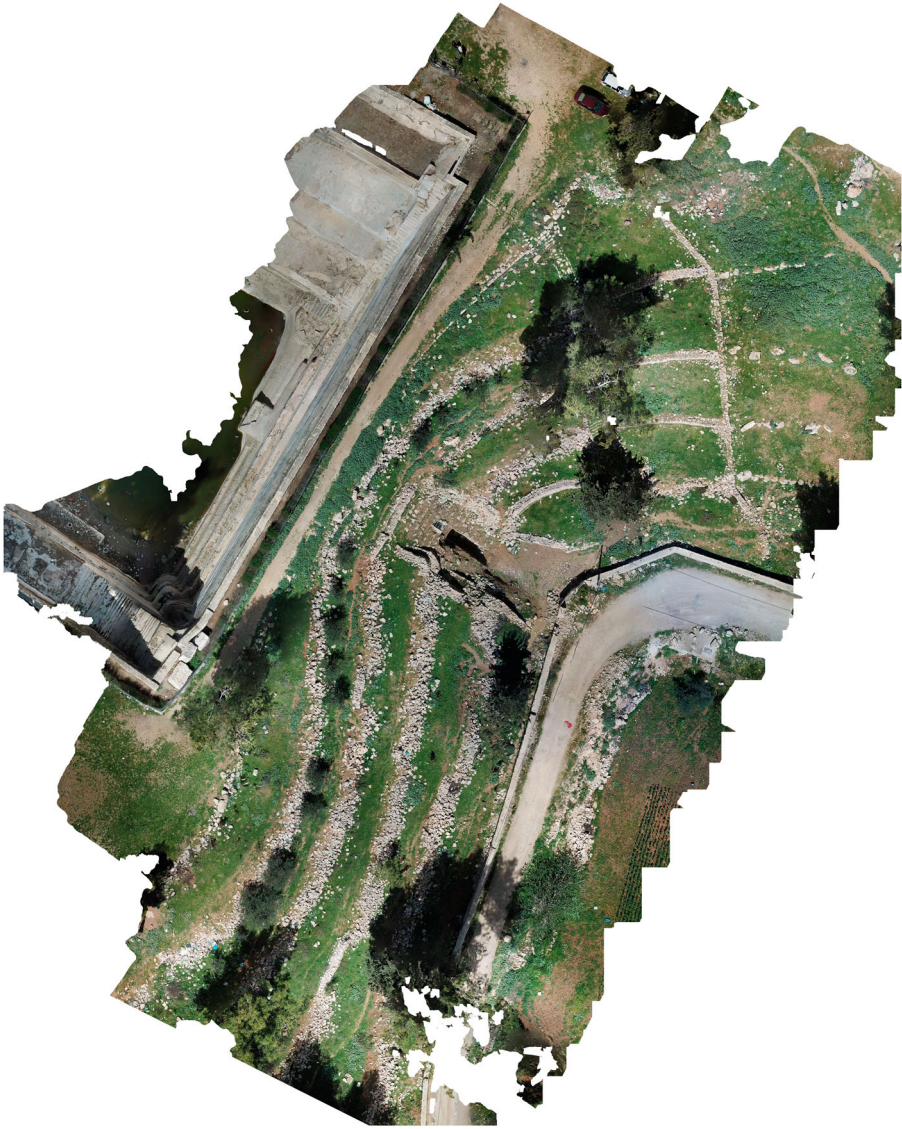
The dam forming the eastern wall of the pool exhibits evidence of multiple phases which fit into the stratigraphic scheme described above (Figure 15). From the interior of the pool, the built portion of the Dam Wall is wholly obscured by the Mandate Period plastering (Figure 16). However, several metres of the interior base of the wall is visible through breaks in the plaster and show that the lowest 7–8 metres is cut directly from the bedrock which was left in place with several interior terraces. There is a large cube of bedrock, roughly three metres to a side, that was left by the original pool quarriers at the bottom centre of the wall. Today a British Mandate Era pipe passes through this cube and is the primary means of extracting water from the pool eastwards into the Artas Valley.

Figure 15. Orthophoto of Dam. North is up.

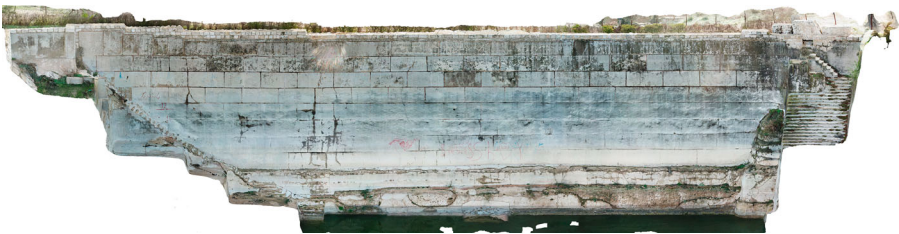
Figure 16. Orthophoto of the interior face of the Dam Wall, facing east.

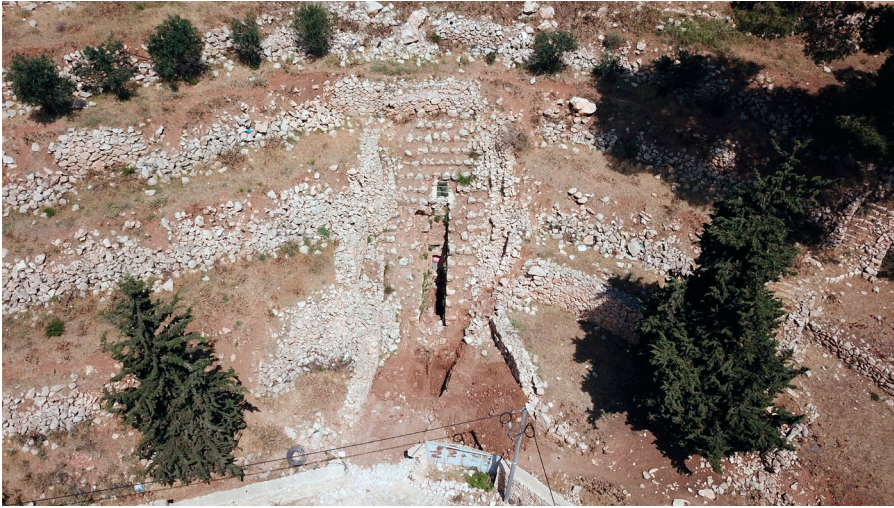
Figure 17. Photo of the Dam exterior from the east. The central opening through the stepped buttress providing access to the Dam interior is surrounded on both sides by modern agricultural terracing.

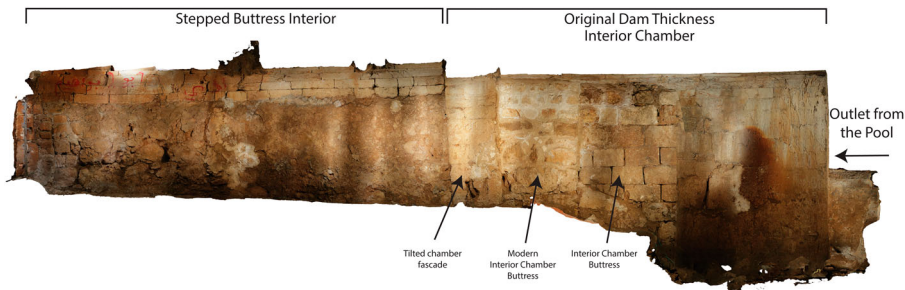
Approximately 10 metres into the dam one can see the seam between the original Dam Wall and the buttress, as well as evidence that the original Dam Wall became structurally compromised, necessitating the addition of the buttress (Figures 20–22). Serious cracks in the ceiling of the original vaulted chamber are present and the front wall of the vaulted chamber (which was part of the facade of the original Dam Wall) has buckled outward,

Figure 20. Orthophotographic section through the Dam passageway and interior chamber, facing south.
